**PROCEEDINGS OF THE THIRTY-THIRD INTERNATIONAL CONFERENCE ON
CEMENT MICROSCOPY**

SAN FRANCISCO, CALIFORNIA, U.S.A.

April 17 – 20, 2011

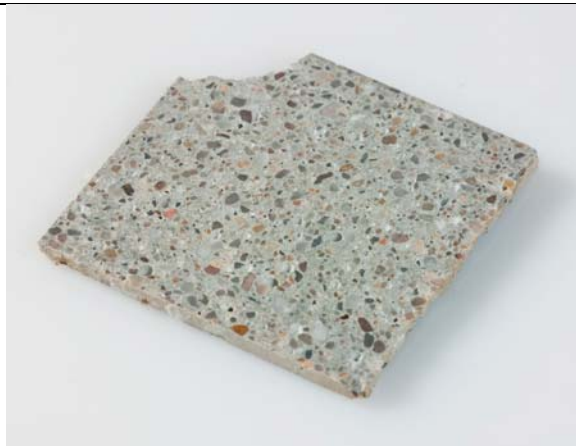
Macroscopic view of the concrete sample
4 x 4 x 0.2cm

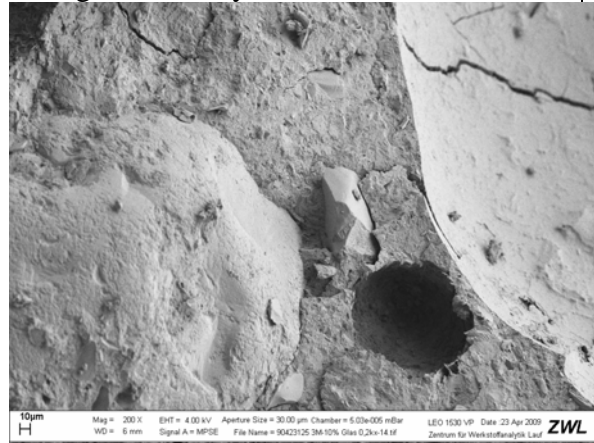
Microscopic sample description, pores,
sand grains and hydrated cement
